**FINAL**  
**KNKT.14.12.29.04**

# **KOMITE NASIONAL KESELAMATAN TRANSPORTASI**

**Aircraft Accident Investigation Report**

**PT. Indonesia Air Asia  
Airbus A320-216; PK-AXC  
Karimata Strait  
Coordinate 3°37'19"S - 109°42'41"E  
Republic of Indonesia  
28 December 2014**

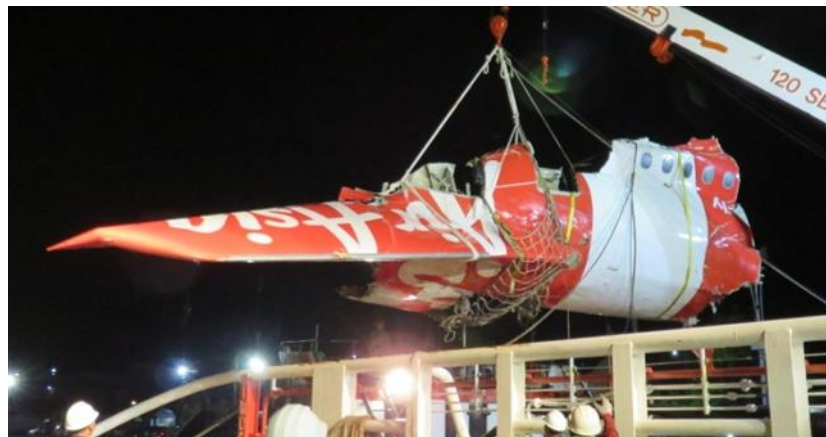
**Figure 3: The recovered tail section being transferred to Kumai Harbour**

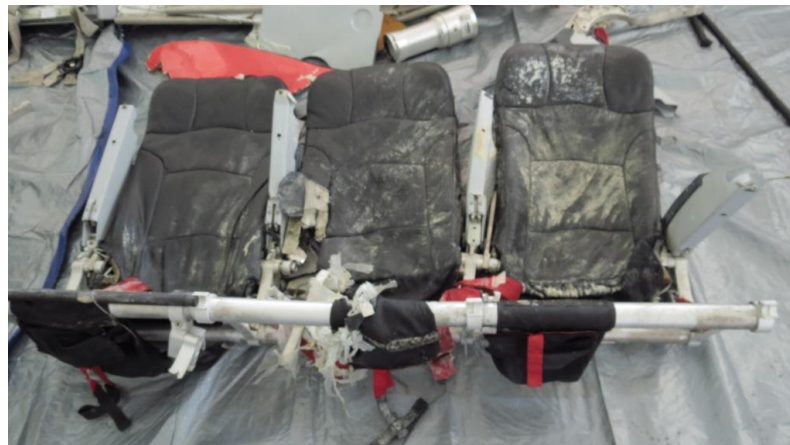
**Figure 4: One section of passenger seats**

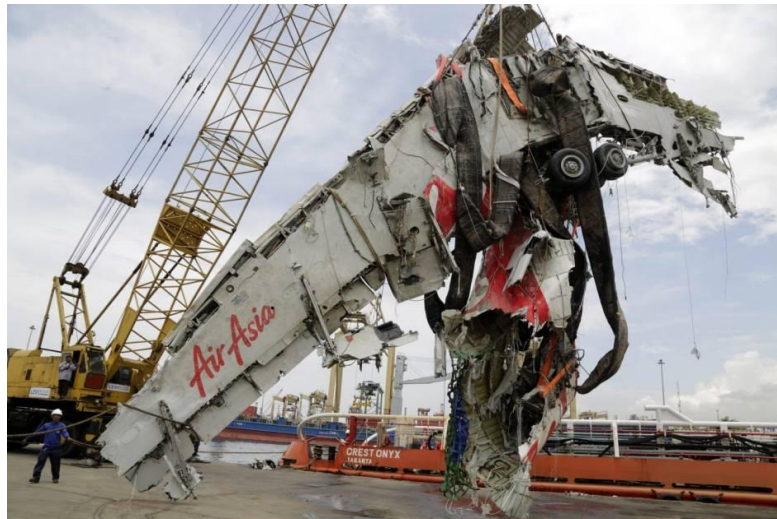
**Figure 5: Centre fuselage section including the wings and main landing gears**

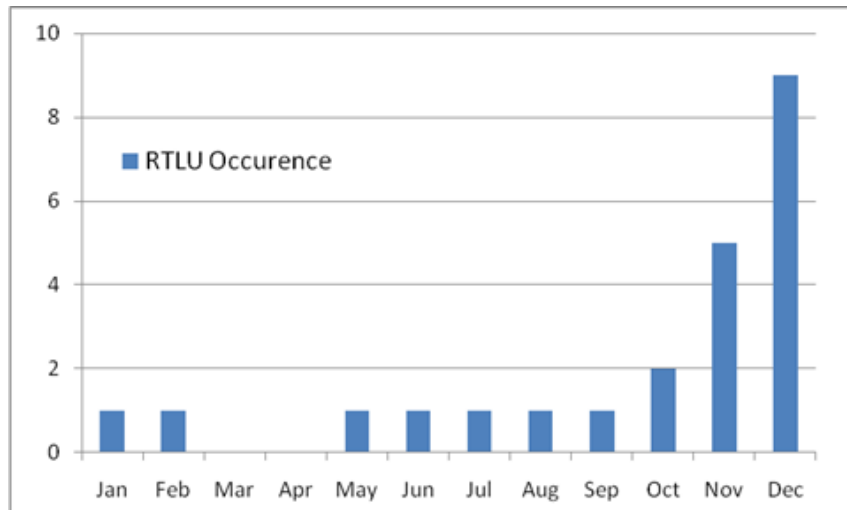
The numbers RTL U occurrences as per PK-AXC 1 Year Maintenance Report were summarized in the following graph.

**Figure 7: Numbers of the RTLU Occurrences in 2014**

The workaround solution of the maintenance staff on the RTLU problems were mostly by resetting computer by either resetting the FAC push button and followed by AFS test or pulling the associated CBs and the rectification was performed according to the A320 TSM.

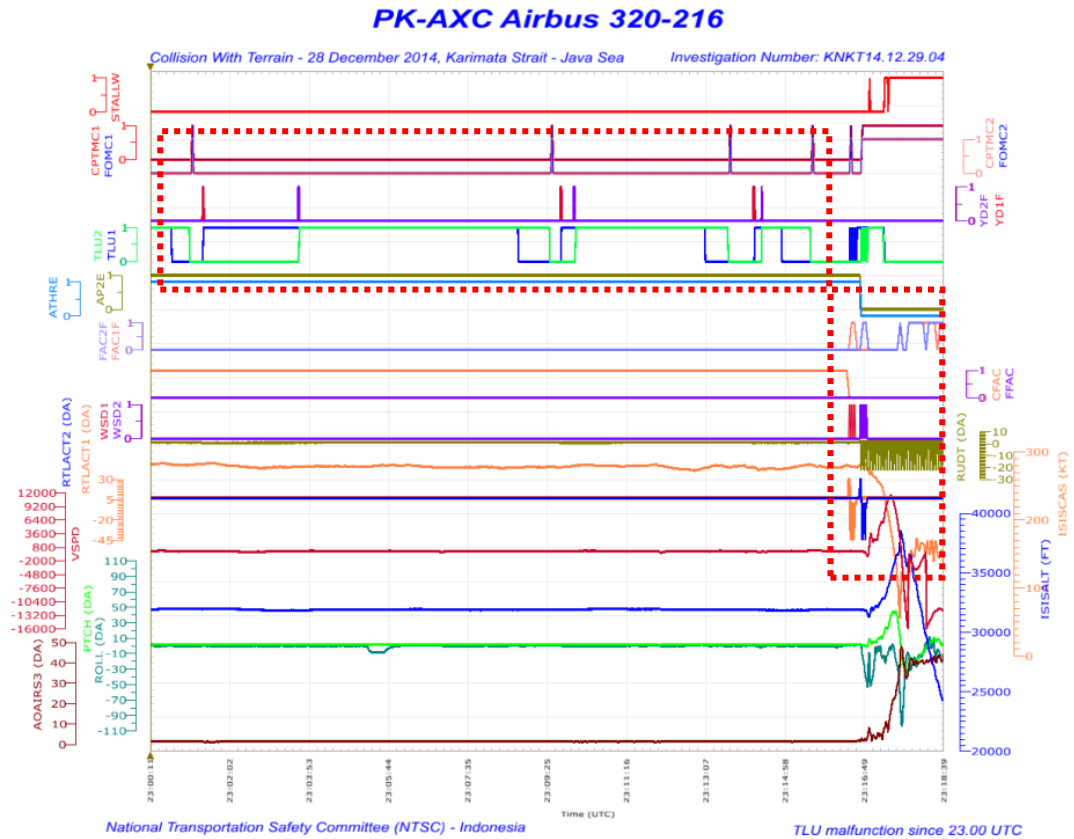
At 2301 UTC, FDR recorded failure on both Rudder Travel Limiter Units and triggered a chime and master caution light. The ECAM message showed “AUTO FLT RUD TRV LIM SYS” (Auto Flight Rudder Travel Limiter System). The PIC read and performed the ECAM action of AUTO FLT RUD TRV LIM SYS to set Flight Augmentation Computer (FAC) 1 and 2 push-buttons on the overhead panel to OFF then to ON one by one. Both Rudder Travel Limiter Units returned to function normally.

At 2309 UTC, the FDR recorded the second failure on both Rudder Travel Limiter Units and triggered a chime and master caution light. The pilots repeated the ECAM action and both Rudder Travel Limiter Units returned to function normally.

At 2313:41 UTC, the single chime sounded and the amber ECAM message “AUTO FLT RUD TRV LIM SYS” was displayed. This was the third failure on both Rudder Travel Limiter Units on this flight. The pilots performed the ECAM actions and the system returned to function normally.

At 2315:36 UTC, the fourth failure on both Rudder Travel Limiter Units and triggered ECAM message “AUTO FLT RUD TRV LIM SYS”, chime and master caution light.

**Figure 20: RTLU problems and pilot actions**

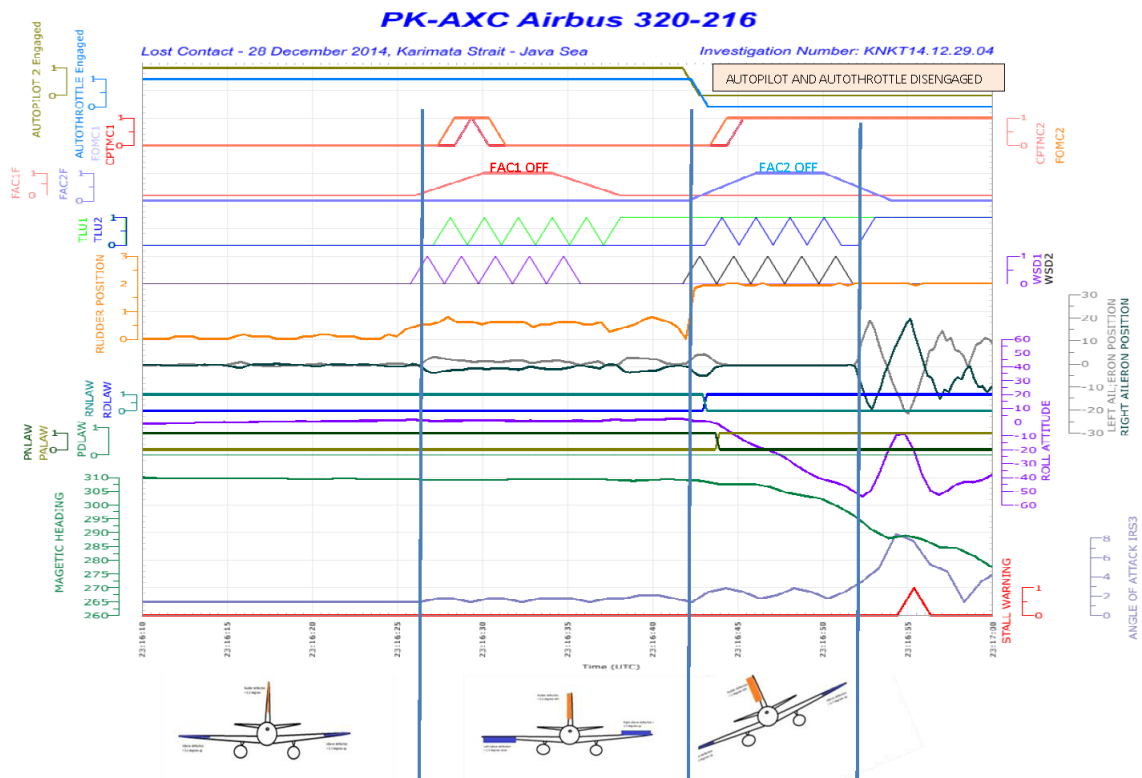
The fifth Master Caution at 2316:28 UTC was triggered by FAC 1 FAULT.

**Figure 21: FDR parameters after the fifth Master Caution**

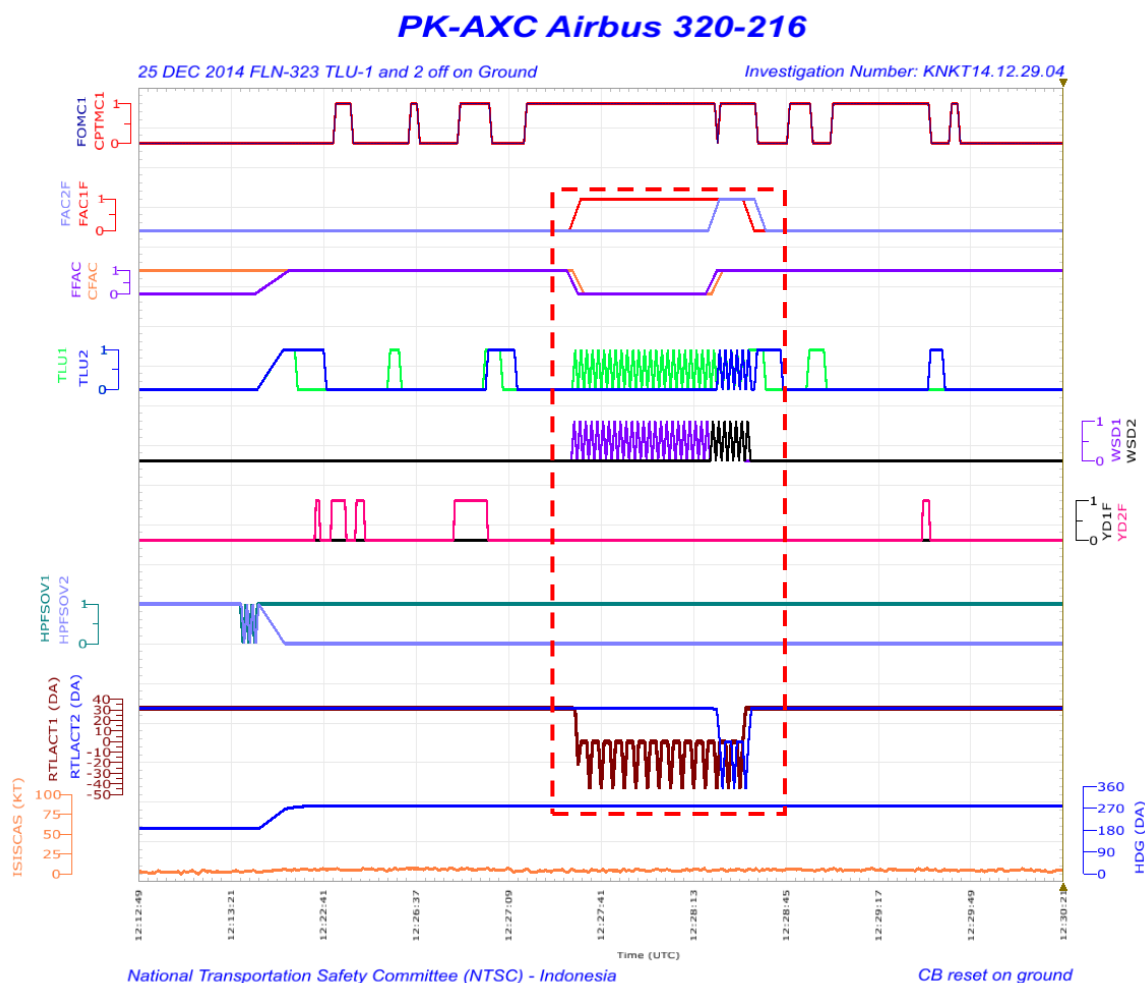
**Figure 24: The FDR parameters of FAC fault followed by CB reset on the ground at 25 December 2014**

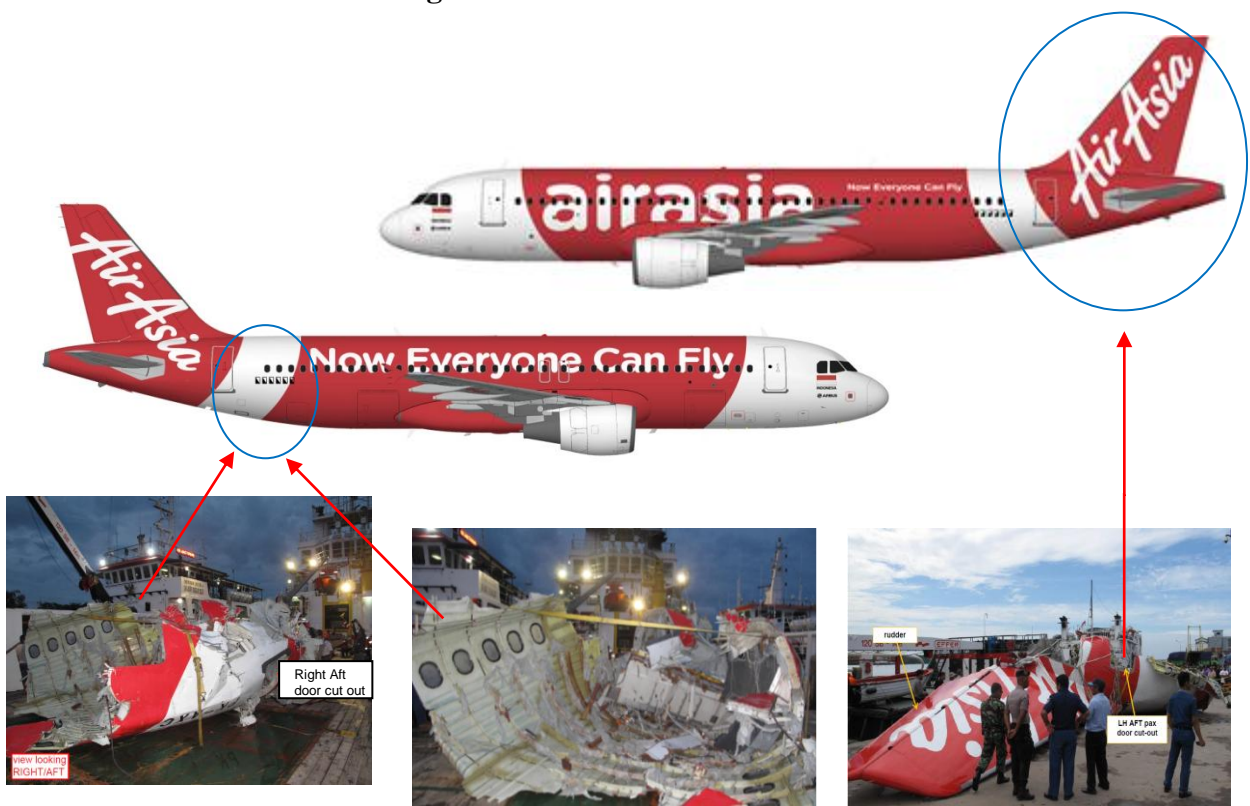
**Figure 32: Pictures of identified parts and its original position**

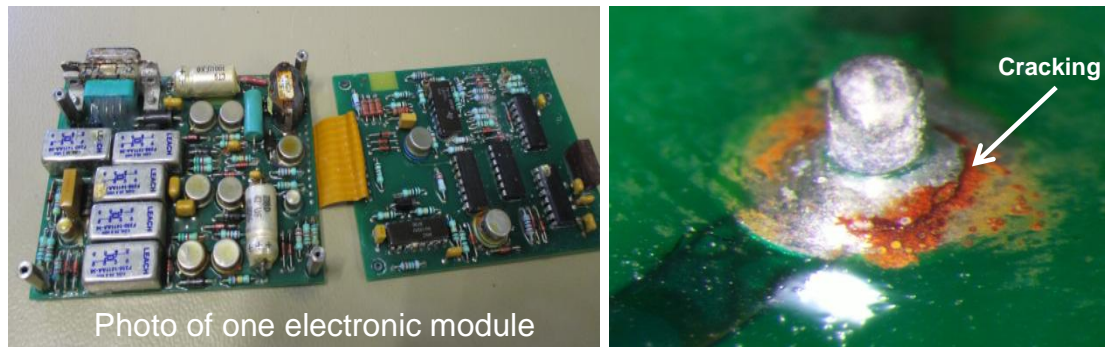
- The cracking of a solder joint of both channel A and B resulted in loss of electrical continuity and led to RTLU failure.
- The existing maintenance data analysis led to unresolved repetitive faults occurring with shorter intervals. The same fault occurred 4 times during the flight.

**Figure 35: Electronic Module of RTLUs**
