# TECHNICAL REPORT

**Accident** to the Airbus A380  
registered F-HPJE an operated by Air France  
on 30/09/2017 en route over **Greenland**

October 2017 - June 2018  
Searches **Phase I & II**

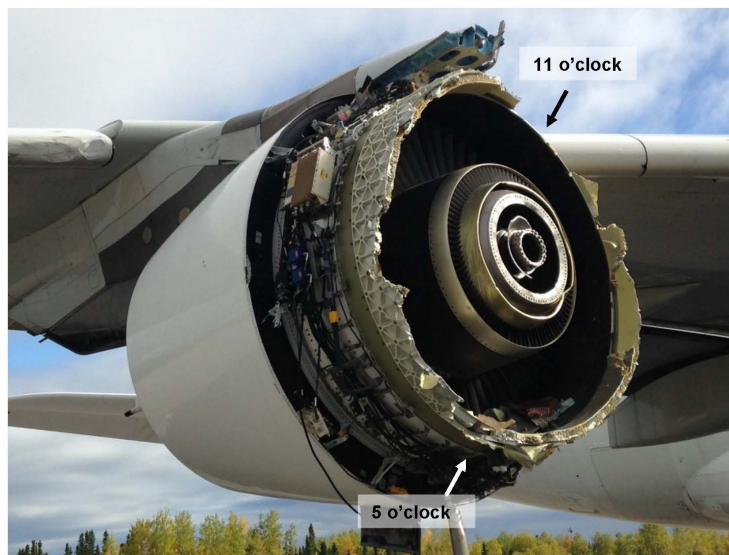
According to the damage observed on the engine, two areas exhibited significant damage consistent with the ejection of fan hub fragments. One was located at the 11 o'clock position on the engine, aft looking forward, the other at the 5 o'clock position (see Fig. 16 & Fig. 17).

Fig. 17: side view of engine N° 4 on aircraft after landing
