**FINAL**  
**KNKT.14.12.29.04**

# **KOMITE NASIONAL KESELAMATAN TRANSPORTASI**

**Aircraft Accident Investigation Report**

**PT. Indonesia Air Asia  
Airbus A320-216; PK-AXC  
Karimata Strait  
Coordinate 3°37'19"S - 109°42'41"E  
Republic of Indonesia  
28 December 2014**

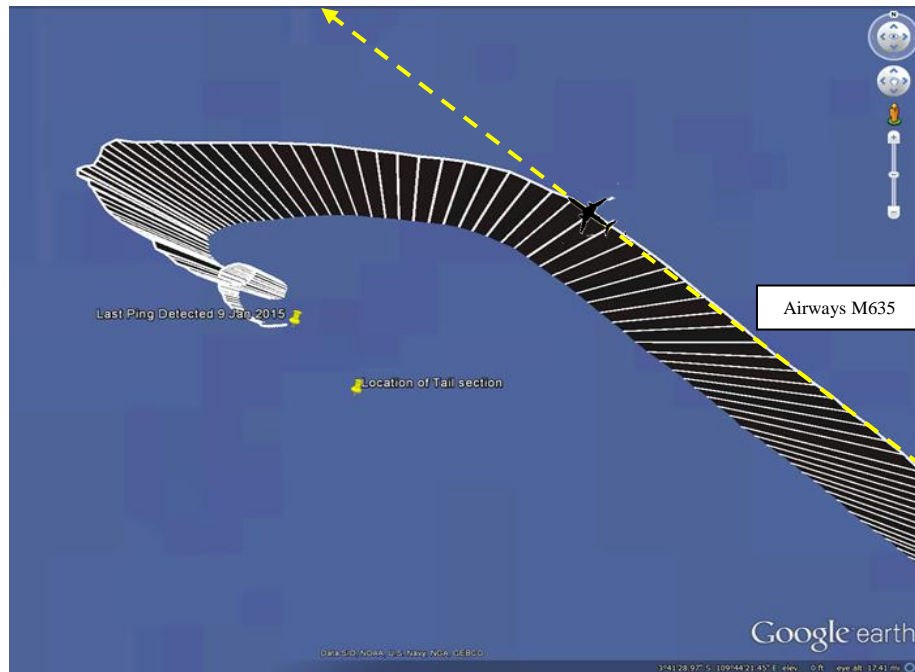
The FDR data showed that while the aircraft was cruising at an altitude of 32,000 feet in normal condition, the aircraft then deviated to the left from airway M635. The master caution triggered by both RTL problems activated 4 times. The fifth master caution was related to the FAC 1 FAULT activating. The sixth master caution was triggered by the FAC 1+2 FAULT and followed by the autopilot and auto-thrust disengaged and flight control law reverted from Normal Law to Alternate Law.

Subsequently the aircraft entered a steep turn and climb, eventually reaching high angle of attack, the stall warning activated and continued until the end of the recording. The FDR and CVR recording ended at 2320:35 UTC.

**Figure 19: Flight path based on FDR data superimposed to the Google Earth**  
 Detail information of the FDR is shown on the following graphs.  
 Note: abbreviation of FDR parameter indication available in the list of abbreviation of FDR parameters.

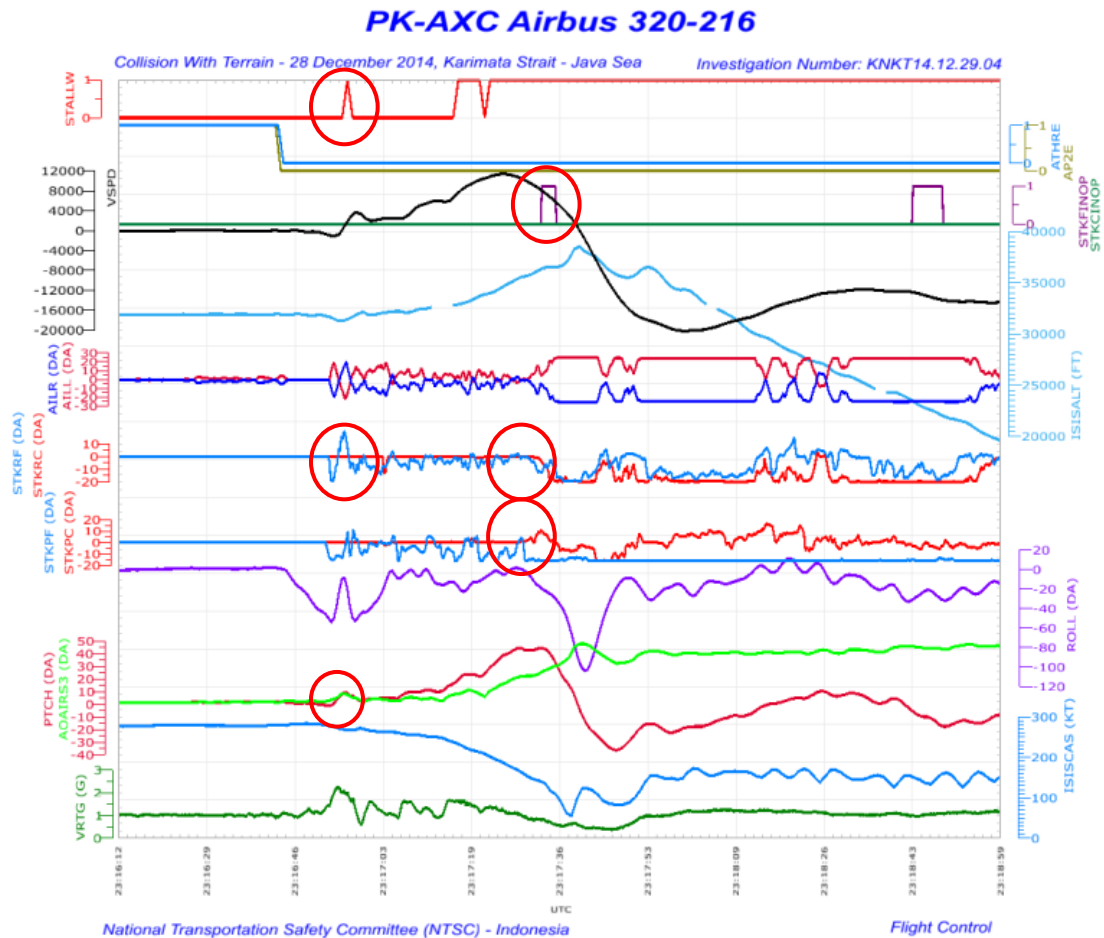
**Figure 22: Pilots inputs on side stick**

- o Fluctuation of parameters of component controlled by FAC 2 such as RTLU 2, Wind Shear Detection 2 and Rudder Travel Limiter Actuator 2
  - o The autopilot and auto-thrust disengaged

- o Flight control law reverted from Normal Law to Alternate Law
  - o Rudder deflected 2° and aileron deflection 0°.
- The aircraft started to roll.
- At 2316:54 UTC the FAC 2 was back to ON and all fluctuating parameters stopped. The autopilot and auto thrust remained disengaged. Flight control law remained in Alternate Law.

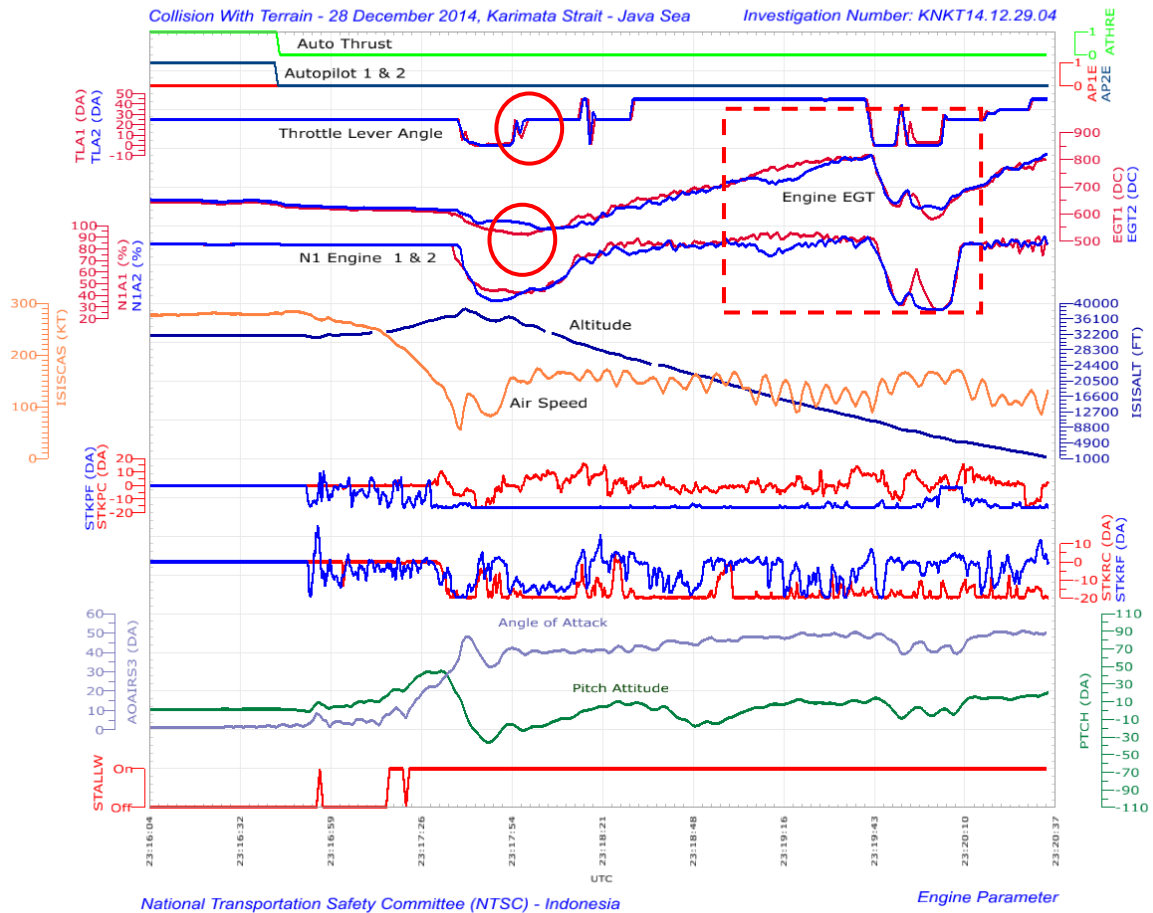
**Figure 23: Thrust levers and side-sticks movement**

- At 2317:41 UTC the aircraft reached the highest altitude of 38,500 feet (ISIS) and largest roll angle at 104° to the left. The aircraft then descended with a rate up to 20,000 feet per minute momentarily afterward the rate of descent was recorded at average of 12,000 feet per minute until the end of recording.

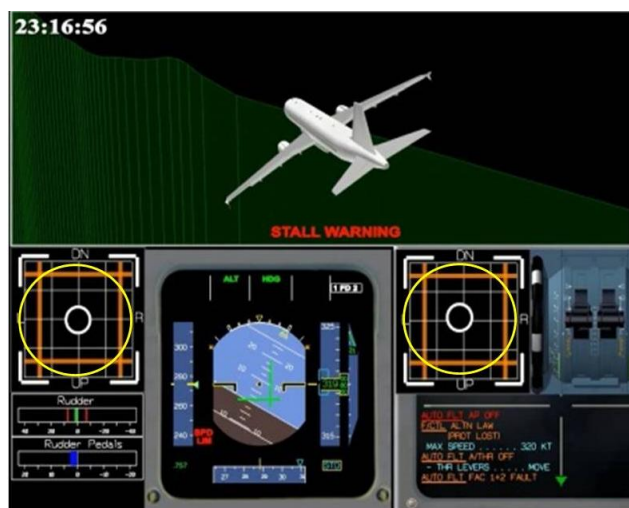
**Figure 26: The first aural Stall warning activated**

Speed (Knots)	268 (ISIS)	272 (CAS)
Altitude (Feet)	31980 (ISIS)	33900 (GPS)
Rudder	2°	
Roll	19.7°	
Pitch	9.5°	
AOA	8°	
VS (fpm)	2624	
N1	83%	
EGT	621 °C	
Side-sticks	<b>PIC</b> P: 0° R: 0°	<b>SIC</b> P: 7° R: +10°

Time (UTC)	From	To	Description
2317:02	P1		Gave instruction “level...level...level...” (4 times)
2317:15	P1		Gave instruction “pull down...pull down” (2 times)

2317:17	Warning		Aural stall warning announced with cricket sound. Change of external airflow sound.
2317:22	P1	P2	Gave instruction “pull down...pull down” (3 times)

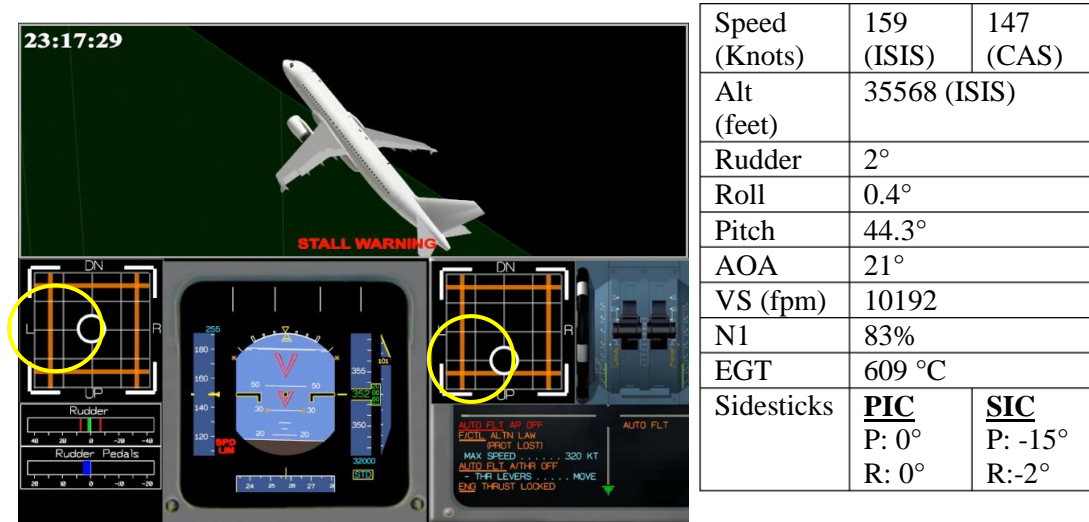
**Figure 27: The aircraft attitude at the highest pitch angle**

Time (UTC)	From	To	Description
2317:23	Warning		Aural stall warning activated with cricket sound and a sound similar to aircraft buffet continued until the end of recording.
2317:25	P1		Gave instruction “pull down...pull down”
2317:29	P2		<i>in French</i> : “What is going wrong”
			The left side stick input continued until the end of recording. Dual input on the side sticks continued until the end of recording.

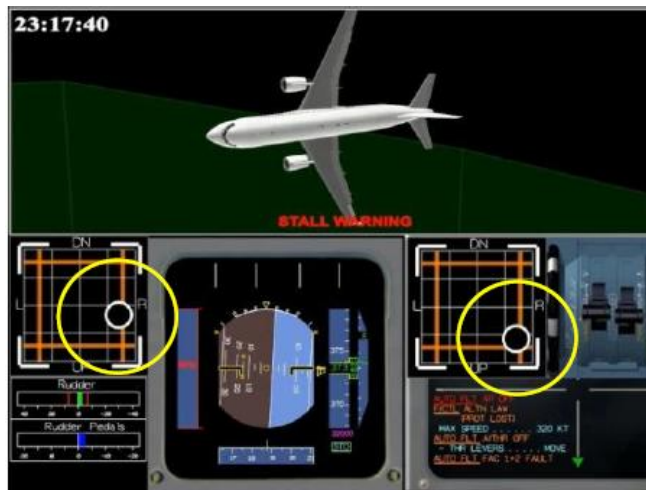
Figure 28: Aircraft in upset<sup>13</sup>situation

Speed (knots)	118 (ISIS)	0 (CAS)
Alt (Feet)	37796 (ISIS)	
Rudder	-5°	
Roll	-104 °	
Pitch	-20.7°	
AOA	46°	
VS (fpm)	-4784	
N1	52%	
EGT	563 °C	
Sidesticks	<b>PIC</b> P: -4° R: -20°	<b>SIC</b> P: -16° R: -17°

Time (UTC)	From	To	Description
2317:41	P1		“My God.”

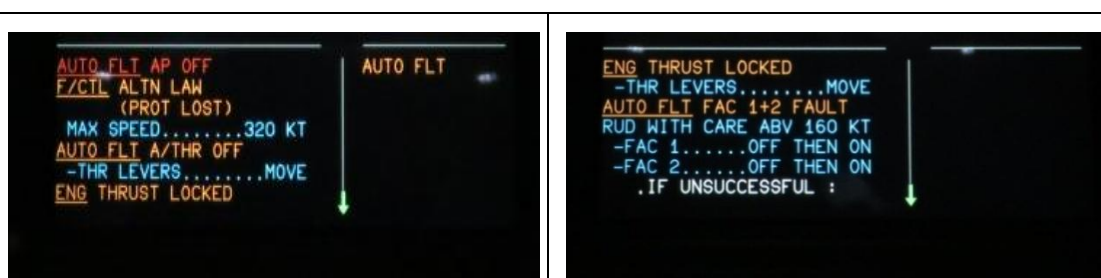
**Figure 33: The page 1 and 2 of the ECAM messages after CBs of FAC 1 and 2 being reset**

- Similar ECAM messages to the data recorded on the FDR appeared when the FAC CBs were pulled.
- Dual input resulted in rapid movement of the aircraft compared to single input
- Dual input in different direction of the side-sticks reduced the ability to control the aircraft.
- The Emergency Cancel Button was effective to prevent pilot distraction for a repetitive malfunction.

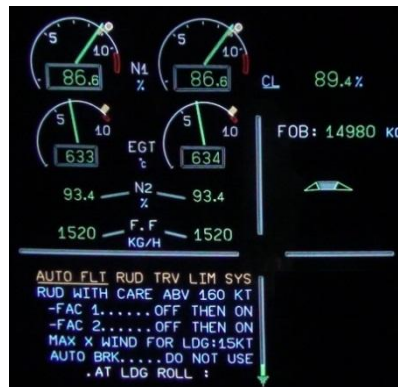
**Figure 34: The ECAM messages after RTLU 1 and 2 fault**

As requested by the KNKT, BEA and Airbus performed the simulator session which referred to FDR data on the engineering simulator. The simulation intended to recreate ECAM messages appeared on the accident flight. The ECAM message during the RUD TRIM LIM SYS problem is presented in the following figure:
